Final Summary Report
Research Project Agreement No. T9233, Task 41
Seismic Vulnerability of the Alaskan Way Viaduct Phase II

**SEISMIC VULNERABILITY OF THE ALASKAN
WAY VIADUCT: SUMMARY REPORT**

1. REPORT NO. WA-RD 363.4	2. GOVERNMENT ACCESSION NO.	3. RECIPIENT'S CATALOG NO.	
4. TITLE AND SUBTITLE SEISMIC VULNERABILITY OF THE ALASKAN WAY VIADUCT — SUMMARY REPORT		5. REPORT DATE July 1995

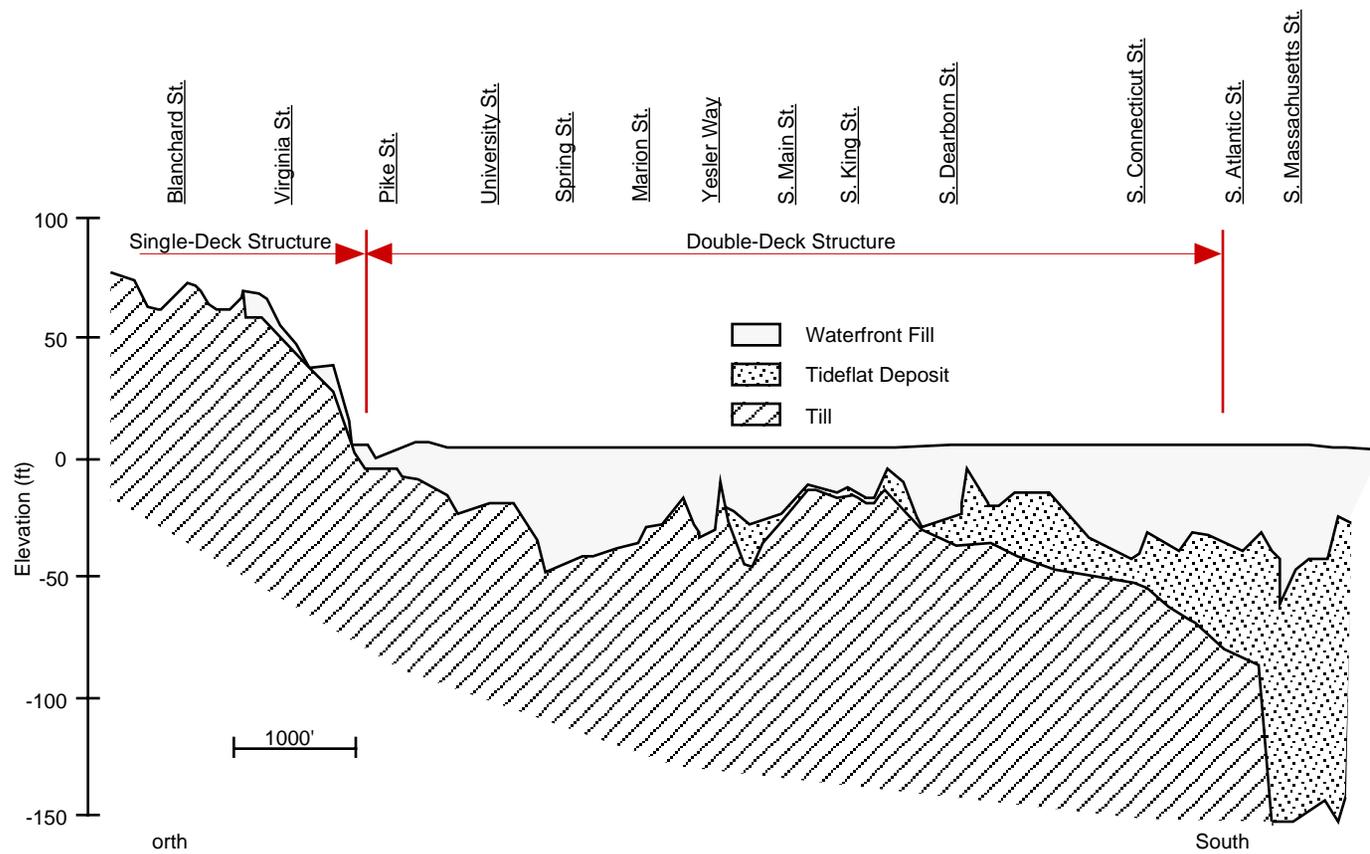
Figure 1. Soil Profile along the Length of the Alaskan Way Viaduct

From the standpoint of geological/geotechnical conditions, the Alaskan Way Viaduct site is dominated by thick deposits of loose, saturated soil. Most of the loose soils were placed as fill during reclamation of the area's tidflats and extension of the waterfront toward Elliot Bay in the late 1800s and early 1900s. Some of the loose soils, particularly those south of about Yesler Way, are natural tidflat soils. The loose soils are underlain by very dense natural soils. The thicknesses of these loose soils vary along the length of the viaduct, as illustrated in Figure 1.

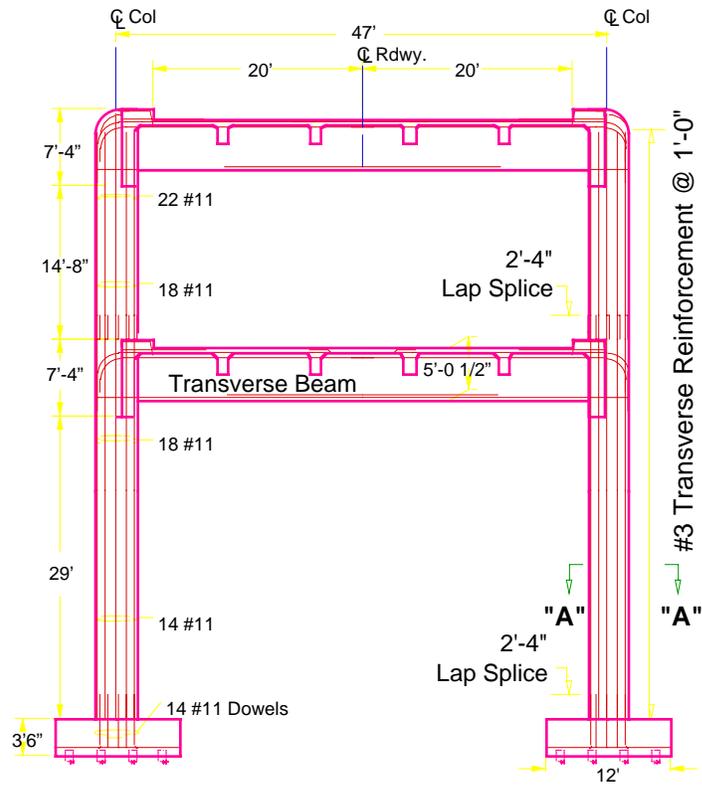
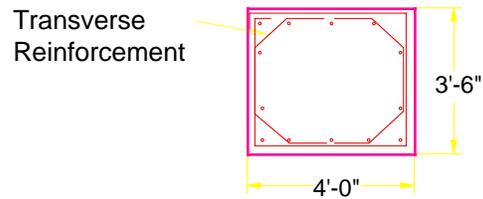
Figure 2. Elevation of Typical Interior Transverse Frame

Another difference between the Alaskan Way Viaduct and modern construction is the presence of longitudinal column reinforcement splices at the column bases and directly above the first deck (Fig. 2). The lap splices are much shorter than those required by current standards, are enclosed by inadequate transverse reinforcement, and

are located in regions that are likely to undergo large flexural demands during an earthquake. Other significant differences between the viaduct and new construction are that the bottom transverse beam and longitudinal girder reinforcement extends into the columns only a short distance, and the footings have no top reinforcement.

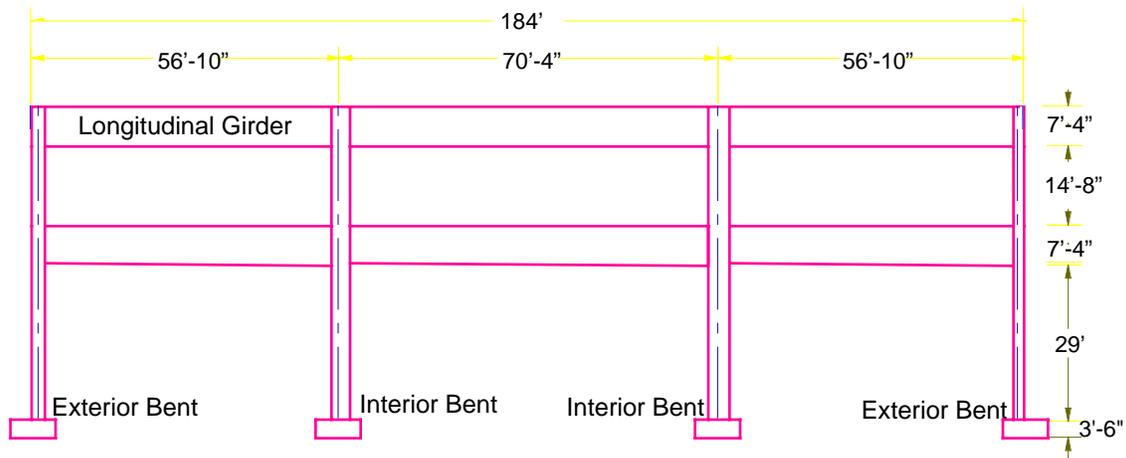
Figure 3. Elevation of Typical Longitudinal Frame

Despite variations to accommodate off-ramps, superelevations and curves, the double-deck portion of the viaduct consists mainly of three-span units that are separated from adjacent units by 2-inch expansion joints. The two decks are supported by beams that run in the transverse direction (perpendicular to traffic) and deep girders that run in the longitudinal direction (parallel to traffic). Unlike many other bridges, the beams and girders frame directly into the columns. In the transverse direction, the beams and columns form four frames that provide the lateral-force resistance of the three-span unit (Fig. 2). The girders and columns form two frames that provide the unit's longitudinal lateral-force resistance (Fig. 3).

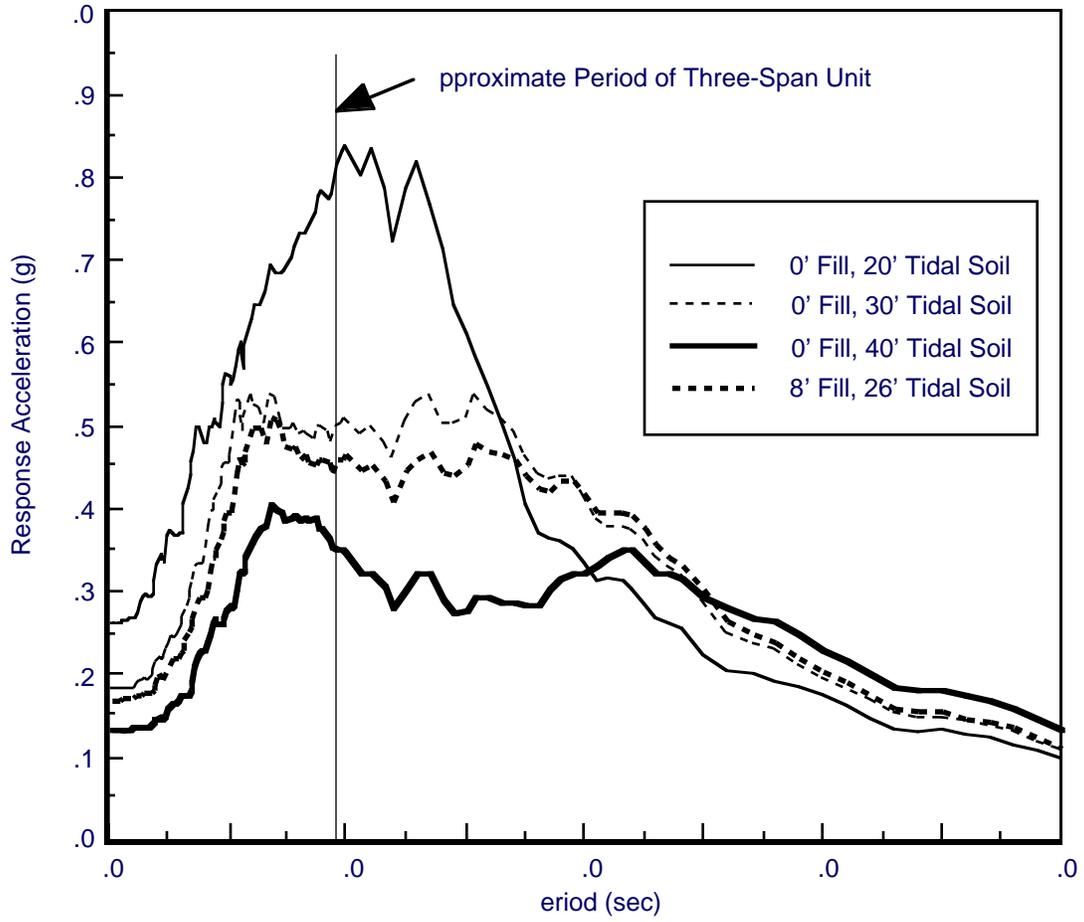
Figure 4. Acceleration Response Spectra

The level of ground shaking at a given site is strongly influenced by the soil conditions at that site. Because soil conditions vary along the length of the Alaskan Way Viaduct, various portions of the viaduct will be subjected to various levels of ground shaking. The viaduct's acceleration levels will likely be highest at locations underlain by 10 to 20 feet of fill; most of these locations are north of about Dearborn Street. South of Dearborn Street, acceleration levels will generally be lower, but larger ground displacements are likely to occur. The variation of the acceleration response for four soil profiles along the length of the viaduct is illustrated in Figure 4.
