M6 Highway Collapse

COVER STORY: Safety First in SMART tunnel project

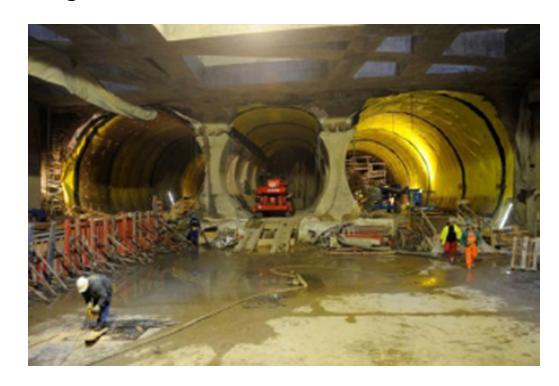
Gallert station excavation on the Budapest Metro Line 4

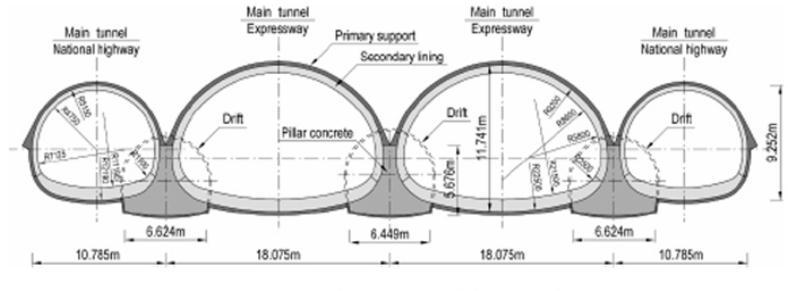
Design of the Shoji Transportation Tunnel in Japan⁽¹¹⁾

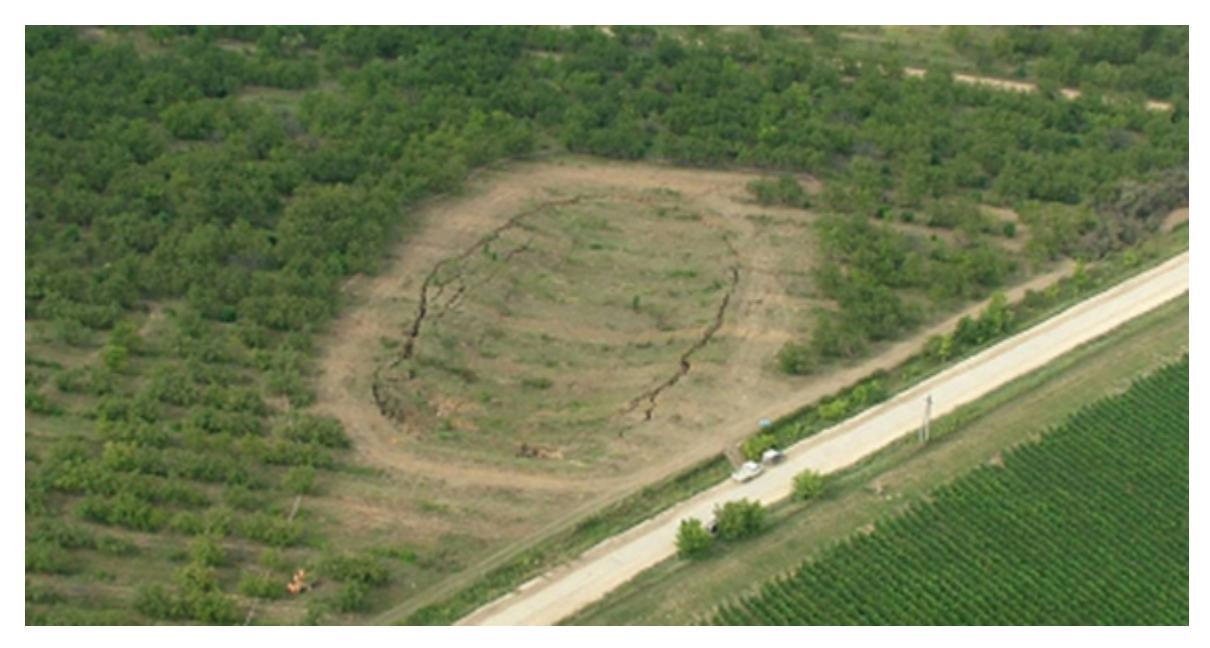
Two paper presentations, and one of the post conference technical tours, was to a long tunnel on the new M6 highway project in Hungary which suffered a major collapse of the twin SCL/SEM tubes a year ago⁽¹³⁾. An initial failure saw a section of about 100m across both tubes collapse and a further 70m behind that collapse a week later. Following stabilization of the zone and installation of support diaphragm walls either side of the alignment, re-excavation of the tunnels through the failed alignment has commenced and was viewed by the technical tour visitors.

Aerial view of the twin tube M6 highway tunnel collapse
