Cairo Metro tunnel collapse

Sep 2009

Shani Wallis, *TunnelTalk*

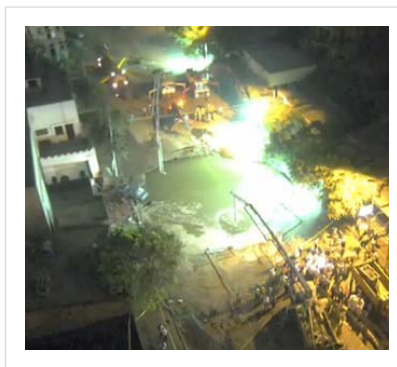
A segment falling out of a ring is reported to be the cause of a sinkhole on a TBM metro tunnel drive in Cairo, Egypt. Details are scarce but a knowledgeable source in Cairo, who wished to remain anonymous, told *TunnelTalk* that it was a segment at about the shoulder point in the previous ring that fell when the last segment of the subsequent ring was being inserted. The segment was in a ring just leaving the tail shield and its fall allowed water and soil to pour into the tunnel under the tailseal, filling the interior of the TBM and the tunnel and generating the ground loss that created the sinkhole crater on the surface.

Slurry filled sinkhole

It took three days to fill the sinkhole with more than 1,000m³ of concrete but this failed to stabilise the situation. The tunnel is being excavated beneath one of the oldest parts of Cairo through ground once covered by the Nile and comprising an upper 8m layer of mixed fill on base deposits of very soft, highly permeable sand and sandy-clay soils, all under a high groundwater table. The weight of the concrete on the soft materials caused a second ground collapse on the following Sunday night.

Recovery of the situation has begun with operation of three grouting machines working around the clock to inject chemical grout, vertically and on inclines, to strengthen the soil around the TBM and the tunnel. This will support a 25m-deep excavation to uncover the TBM, repair the broken ring, and eventually clear out the buried TBM.

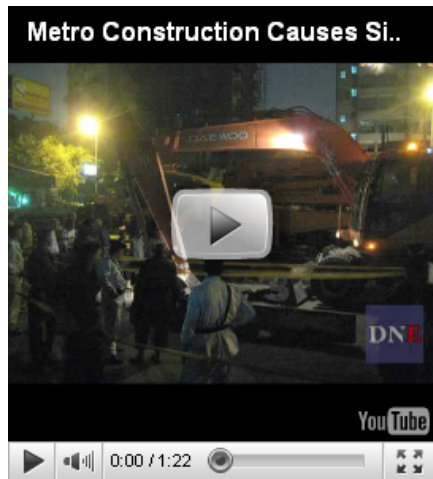
There were no injuries and no structural damage to buildings in the area although 80 families in 10 buildings were evacuated pending safety inspections. A parked car also slid into the 15m-20m diameter x 20m deep sinkhole when it appeared on Thursday night, 3 September. Another six parked cars were saved from doing the same and traffic on Al-Geish Street came to a stop when people saw the street sinking.

Sheet piling or diaphragm walls are being considered for support of the recovery excavation and if the grout injection proves ineffective, ground freezing is an ultimate option.

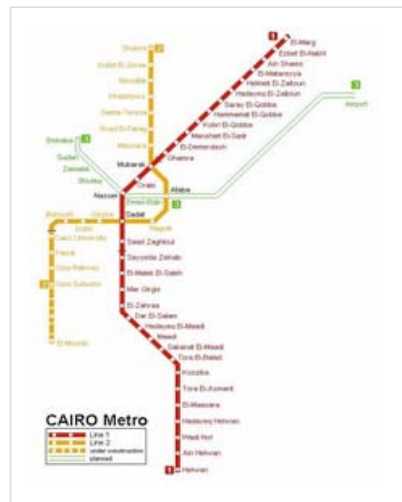
Cairo Metro network
