Cairo Metro tunnel collapse Sep 2009

Shani Wallis, *TunnelTalk*

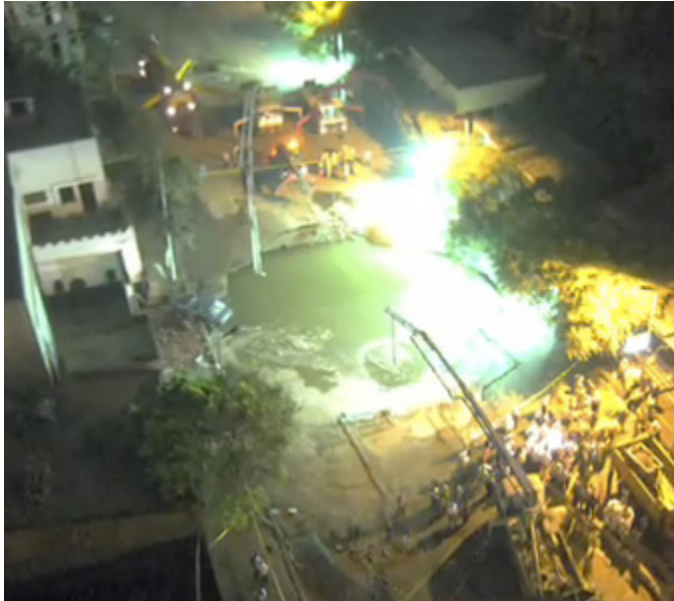
Slurry filled sinkhole

A segment falling out of a ring is reported to be the cause of a sinkhole on a TBM metro tunnel drive in Cairo, Egypt. Details are scarce but a knowledgeable source in Cairo, who wished to remain anonymous, told *TunnelTalk* that it was a segment at about the shoulder point in the previous ring that fell when the last segment of the subsequent ring was being inserted. The segment was in a ring just leaving the tail shield and its fall allowed water and soil to pour into the tunnel under the tailseal, filling the interior of the TBM and the tunnel and generating the ground loss that created the sinkhole crater on the surface.

Sheet piling or diaphragm walls are being considered for support of the recovery excavation and if the grout injection proves ineffective, ground freezing is an ultimate option.

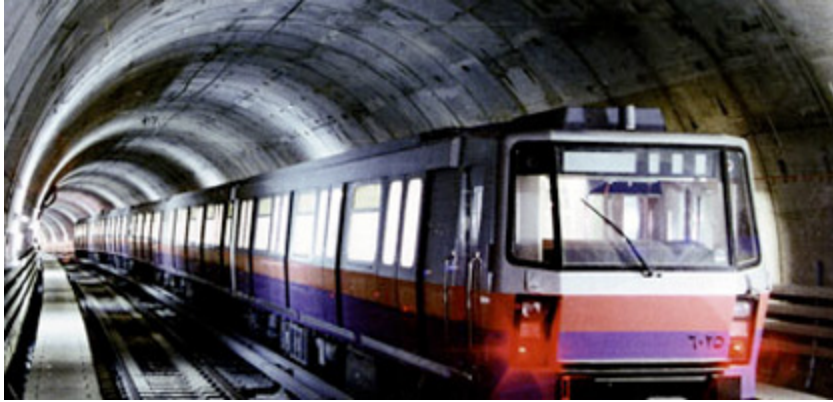
Line 2 running tunnel in operation
